**ORANGE Cleantech Inc.'s
innovative *clean-in-process*
technology**

Coating: a viable way to prevent shell & tube heat exchanger fouling, reduce the carbon footprint of equipment and lower CAPEX

By Martino Donelli, Donelli Group, Italy and Christoph Fischer-Zernin, SÄKAPHEN, Germany

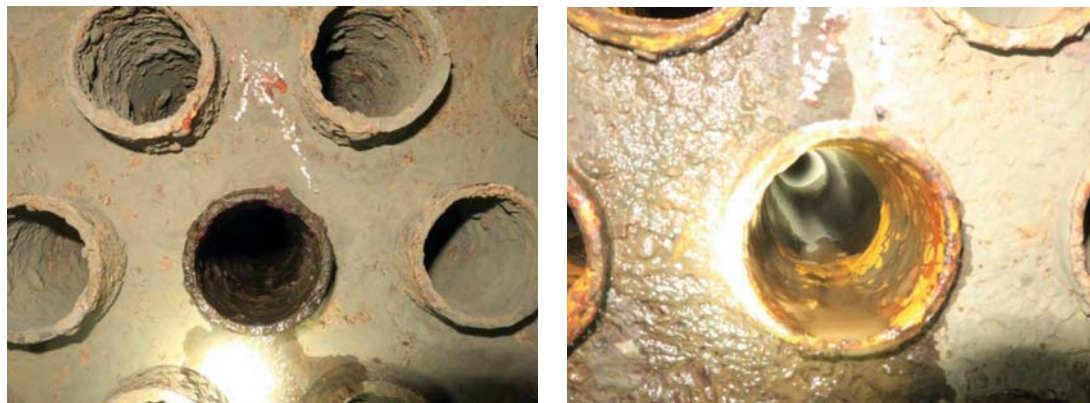
▲ Fig. 6. On the left an uncoated HE and a HE coated with SÄKAPHEN® Si 17 TC on the right. HE coated with SÄKAPHEN® Si S17® TC after 14 months in service during inspection after cleaning: no fouling, no deposit (yellow = touch-up paint applied by client after mounting the coated tubes).

The second case study is from HE tubes internally coated for trial in a large cooler battery located inside ROGESA (former part of Dillinger Hütte/Germany) steel mill. In Figure 6 it is possible to observe a coated and an uncoated HE. On the uncoated HE, the increase in roughness and the reduction in cross section of the pipes is clearly noticeable. Therefore, the pressure drop along the uncoated HE would be significantly higher and the heat transfer rate significantly lower.
